NASA/TM-2001-210846

Structural Testing of a Stitched / Resin Film Infused Graphite-Epoxy Wing Box

*Dawn C. Jegley and Harold G. Bush
Langley Research Center, Hampton, Virginia*

April 2001

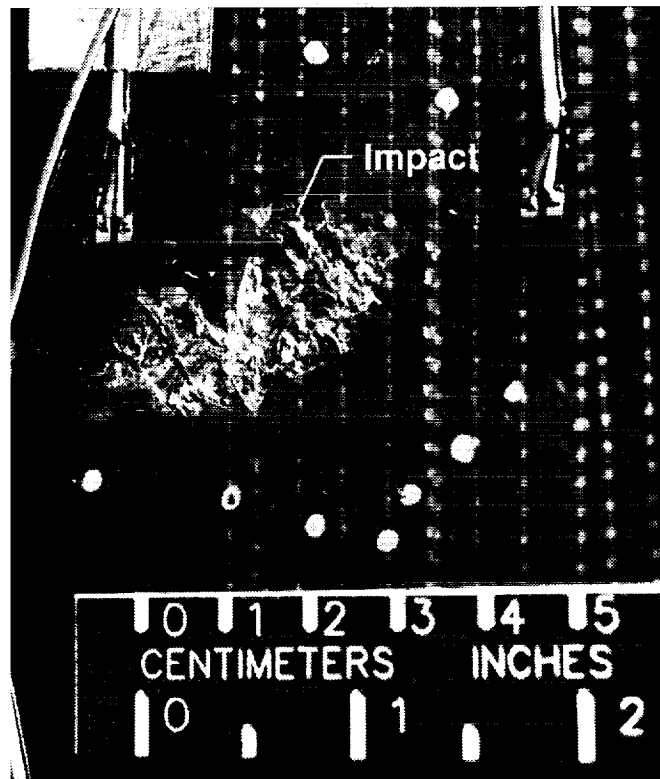
a) Site at rib 4
Figure 16. Upper cover impact damage locations.

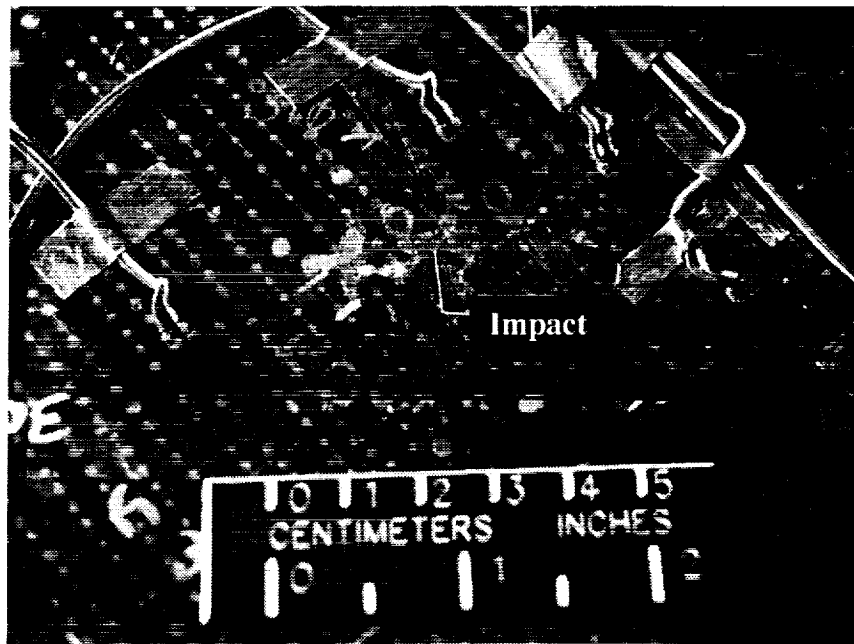
b) Site at rib 9
Figure 16. Continued.

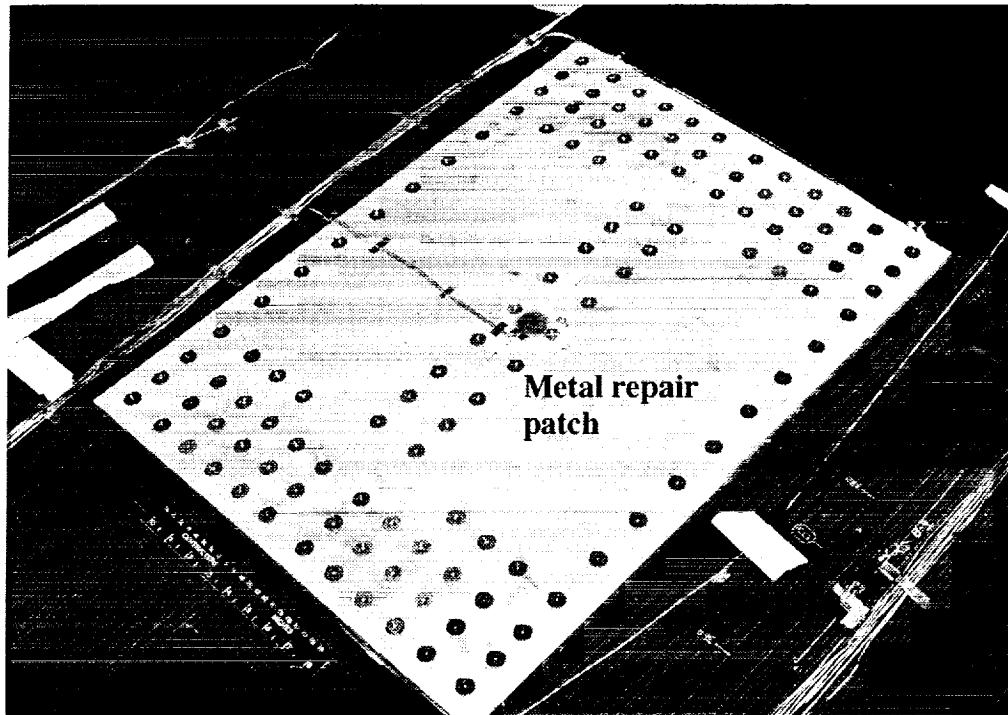
a) Upper cover panel

Metal patch repairs were used to restore the wing to full load-carrying capability after test 7 in which the test article was subjected to load in the presence of discrete source damage. The region of damage was removed then the repairs added. The repairs consisted of a metal plate which conformed to the wing surface on the outer surface of the cover panels and internally spliced stringers. All parts of the repair were attached to the wing with mechanical fasteners. Sketches of the repairs are shown in figure 14. Photographs of the repairs are shown in figure 18.

Figure 18. Repairs to cover panels.

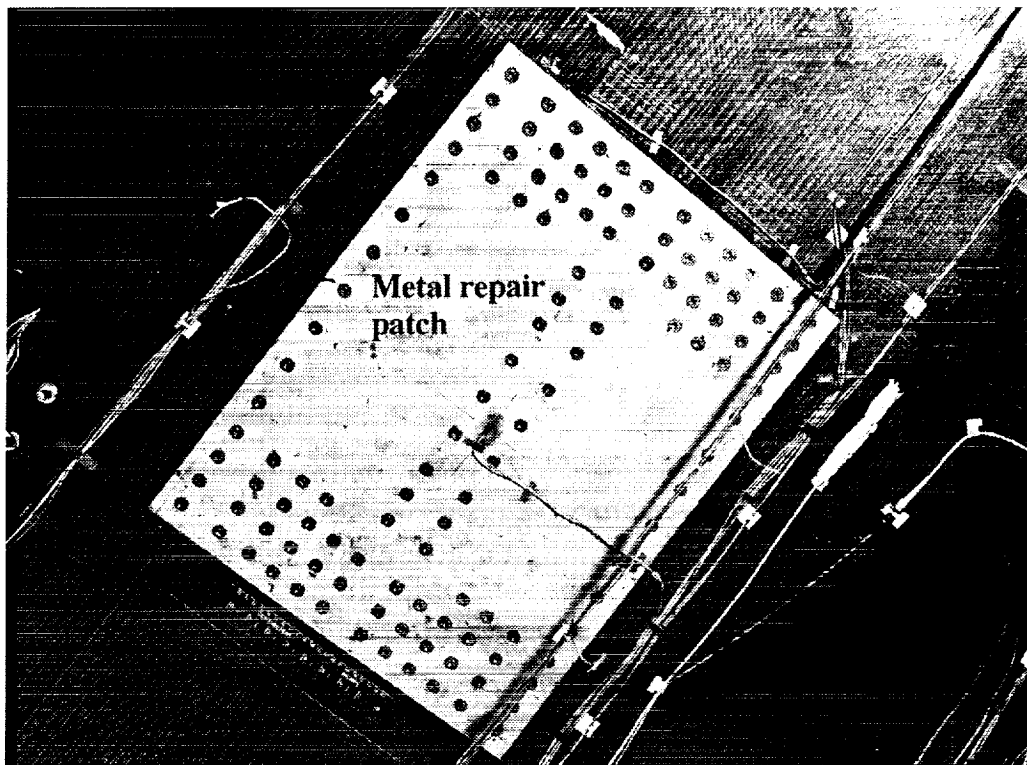
b) Lower cover panel.

Figure 18. Concluded.

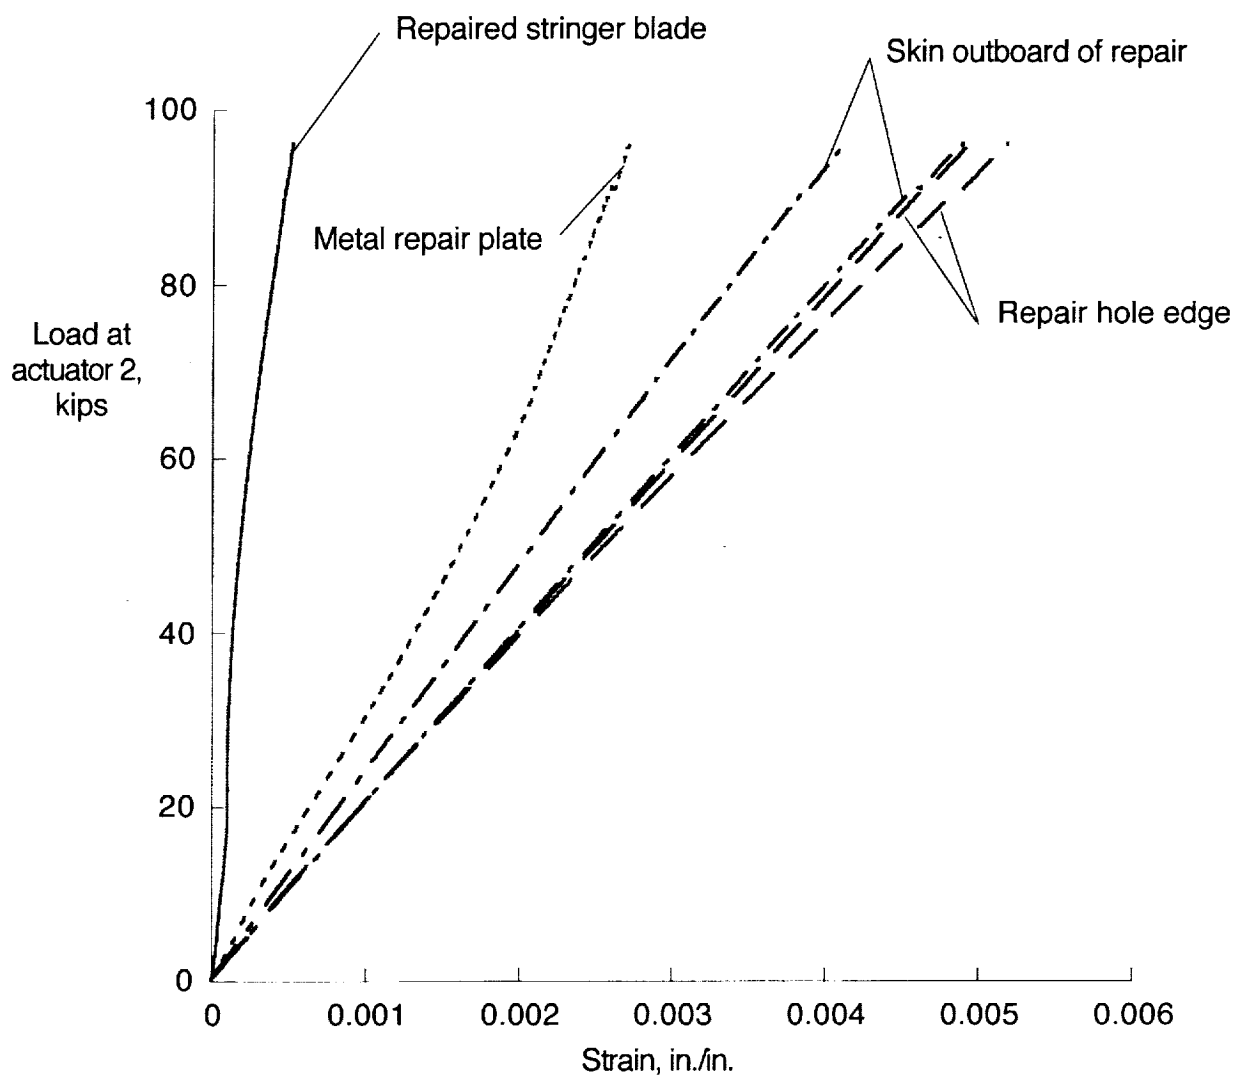
Both sawcuts were repaired prior to the final test (test 8). The strains measured in the lower cover panel repair are shown in figure 64. The solid line represents strain in the metal component of the spliced blade. The short dashed line represents the strain in the metal repair plate. The long dashed lines represent the strain at the edges of the repair bole. The alternating long and short dashes represent the strain in the composite skin immediately outboard of the metal plate. The location of these strain gages is shown in figure 14. Strains on the composite structure in the vicinity of the repair are linear and do not exceed 0.005 in./in. Strains in the metal repair components display nonlinearity but remain less than 0.003 in./in.

Figure 64. Strains in lower cover repaired region. Strain gage locations are shown in figure 14.

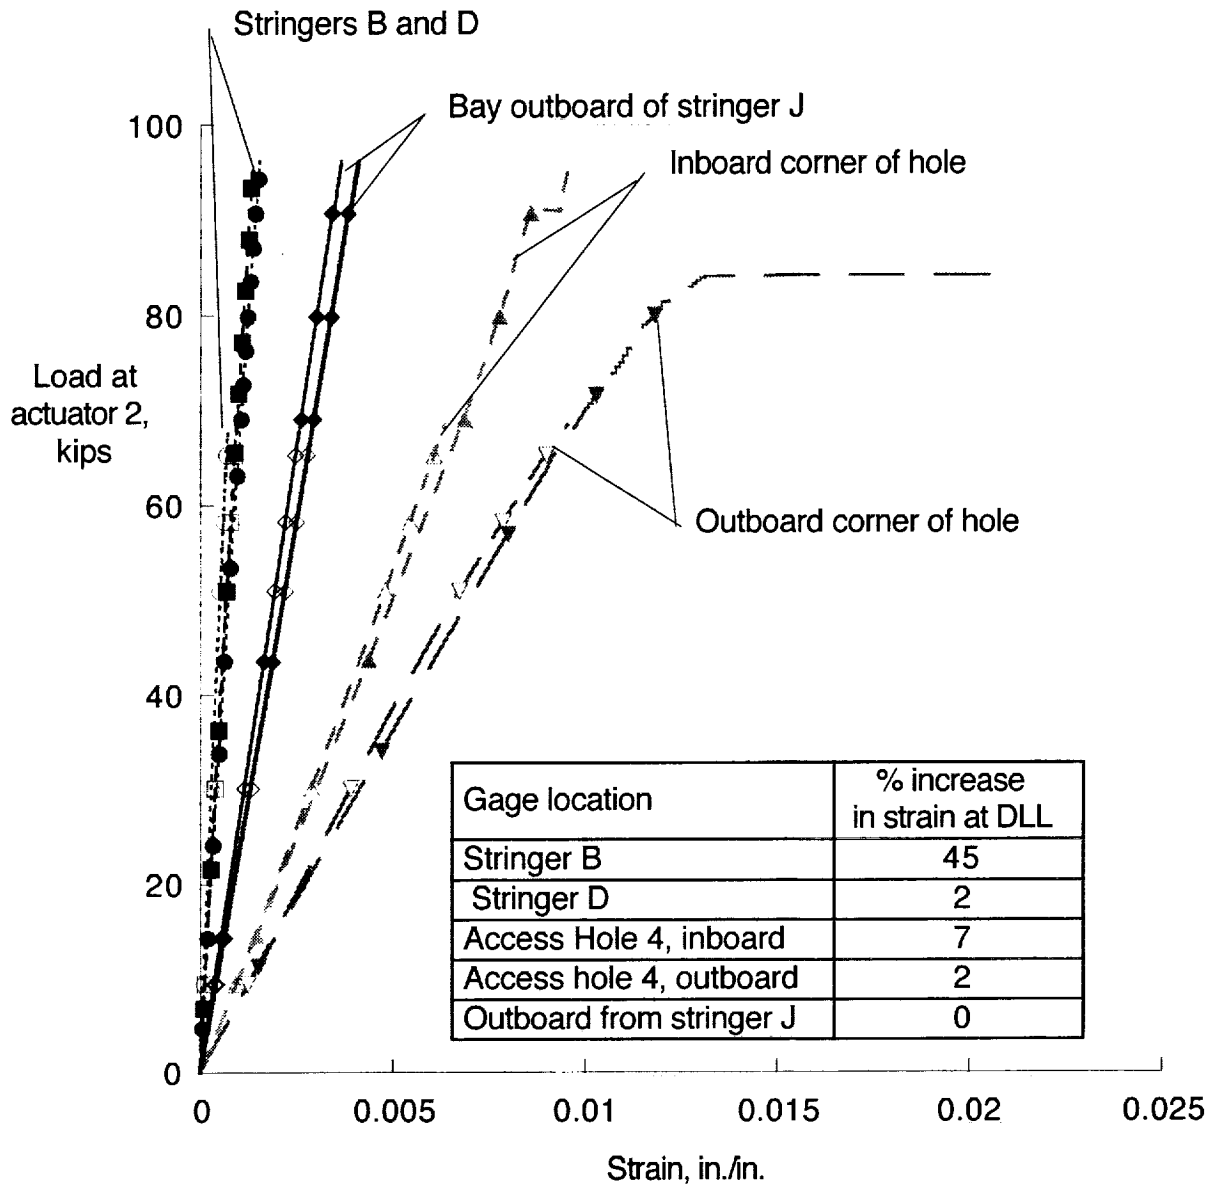
The effect of the lower cover panel repair on the behavior of the lower cover panel strains can be seen by comparing the strains measured in test 6, when the wing was loaded to DLL, to the strains measured in the final test. Measured strains at six locations between ribs 8 and 9 in the lower cover panel are shown in figure 65. These locations are shown in figure 8 as L4 (skin outboard from stringer J), L5 (stringer D) and L6 (stringer B) and at the corners of access hole 4. Solid lines represent strain in the skin outboard of stringer J. Dashed lines with progressively shorter dashes represent strains moving toward the front spar. Open symbols represent data from test 6 and filled symbols represent data from test 8. The repair causes

an increase in strain in the blades of the stringers adjacent to the spliced stringer. At the load values corresponding to DLL, an increase of 45% in stringer B, 2% at the outboard corner of the access hole and 7% at the inboard corner of the access hole is seen. No increases in strain are seen in the skin near the rear spar in this bay. Significant local effects are seen but there is little effect away from the repair site. The effect of the repair on the strains at the access holes in the lower cover is presented in table 7 where strains measured at DLL in test 6 and in test 8 are shown.

Figure 65. Strains in lower cover panel between ribs 8 and 9 for tests 6 and 8. Stringer identification shown in figure 2b.

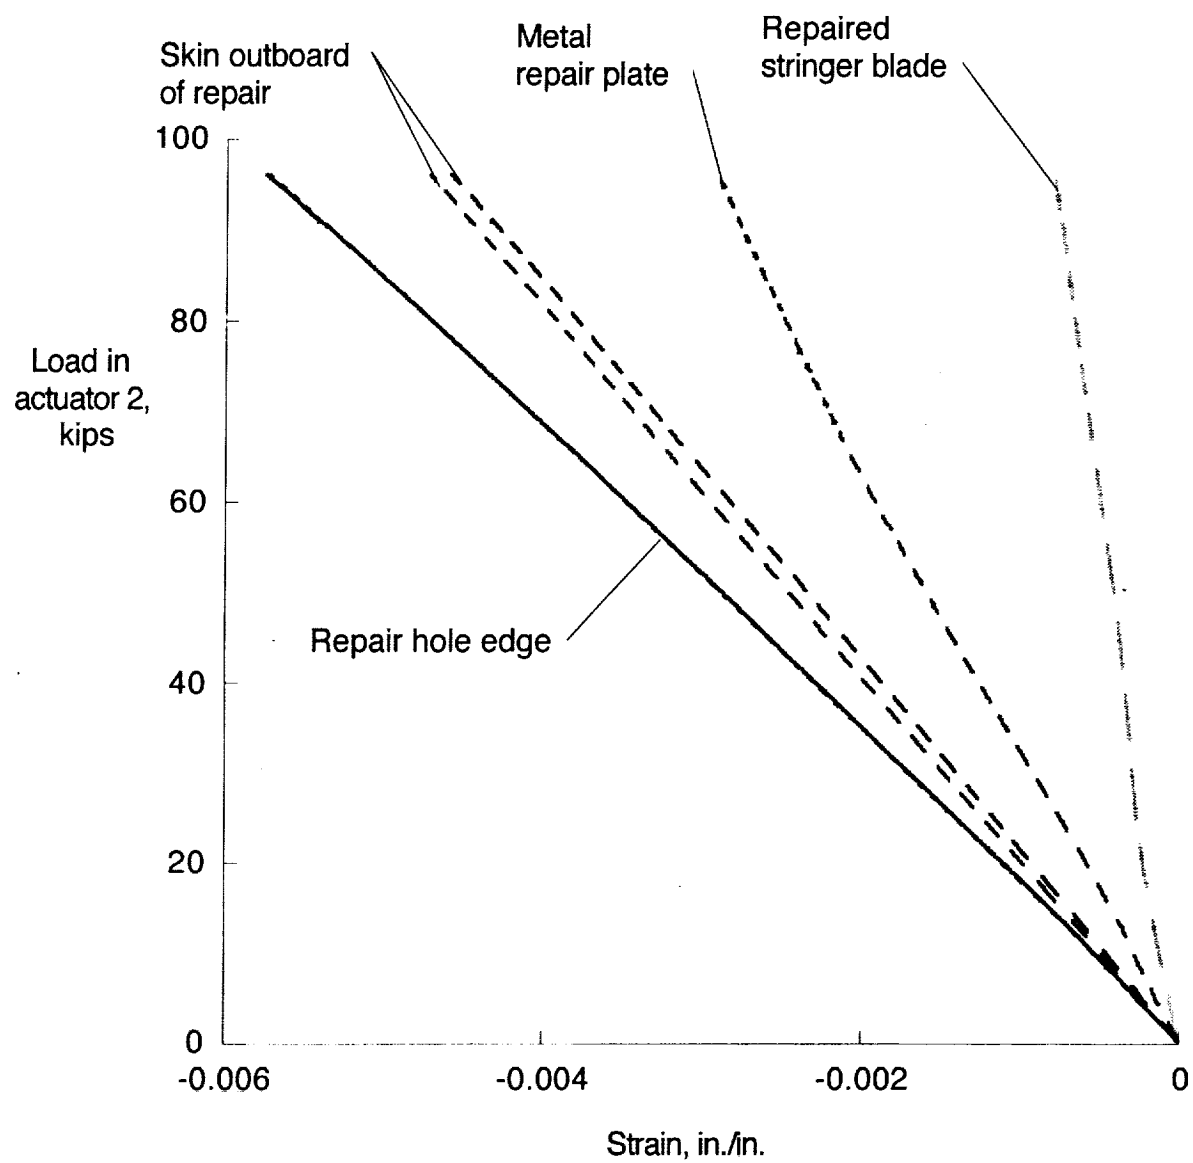
The strains measured in the upper cover panel repair are shown in figure 66. The solid line represents strain in the metal component of the spliced blade. The short dashed line represents the strain in the metal repair plate. The long dashed lines represent the strain at the edges of the repair hole. The alternating long and short dashes represent the strain in the composite skin immediately outboard of the metal plate. The location of these strain gages is shown in figure 14. Strains on the composite structure in the vicinity of the repair are linear and do not exceed 0.005 in./in. Strains in the metal repair components display nonlinearity but remain less than 0.003 in./in.

Figure 66. Strain in upper cover panel repair. Strain gage locations are shown in figure 14.

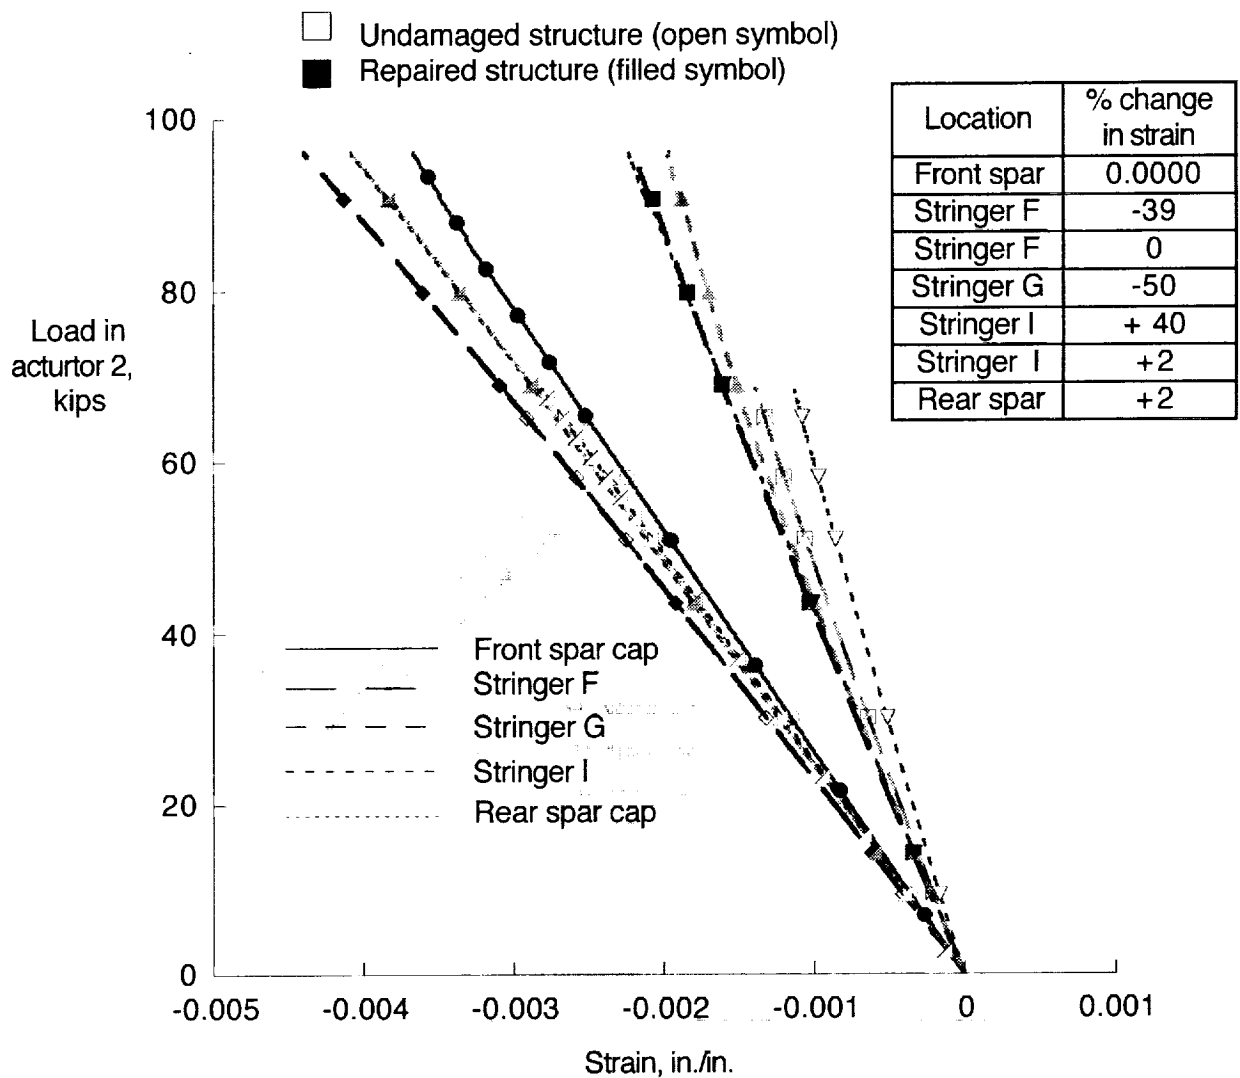
Measured strains at eight locations in the upper cover panel between ribs 10 and 11 are shown in figure 67. These locations are shown in figure 7 as U4 (rear spar cap), U5 (stringer I), U6 (stringer G), U7 (stringer F), and U8 (front spar cap). The solid lines represent the strain in the front spar cap. Long dashed lines represent strain in stringers G and I which are adjacent to the spliced stringer. Short dashed lines represent strain in stringer F. Open symbols represent data from test 6 and filled symbols represent data from test 8. The repair causes an increase in strain in the blades of the stringers to the rear of the spliced stringer and a decrease in strain in the blades of the stringers forward of the repair. At the load values corresponding to DLL, a decrease of 50% and an increase of 40% are seen in the adjacent stringers forward and aft stringers, respectively. The repair causes an increase in strain of 2% at the rear spar and has no effect on the front spar. The strain in the skin is effected little by the repair.

Figure 67. Effect of repair on measured strains in upper cover panel between ribs 10 and 11.

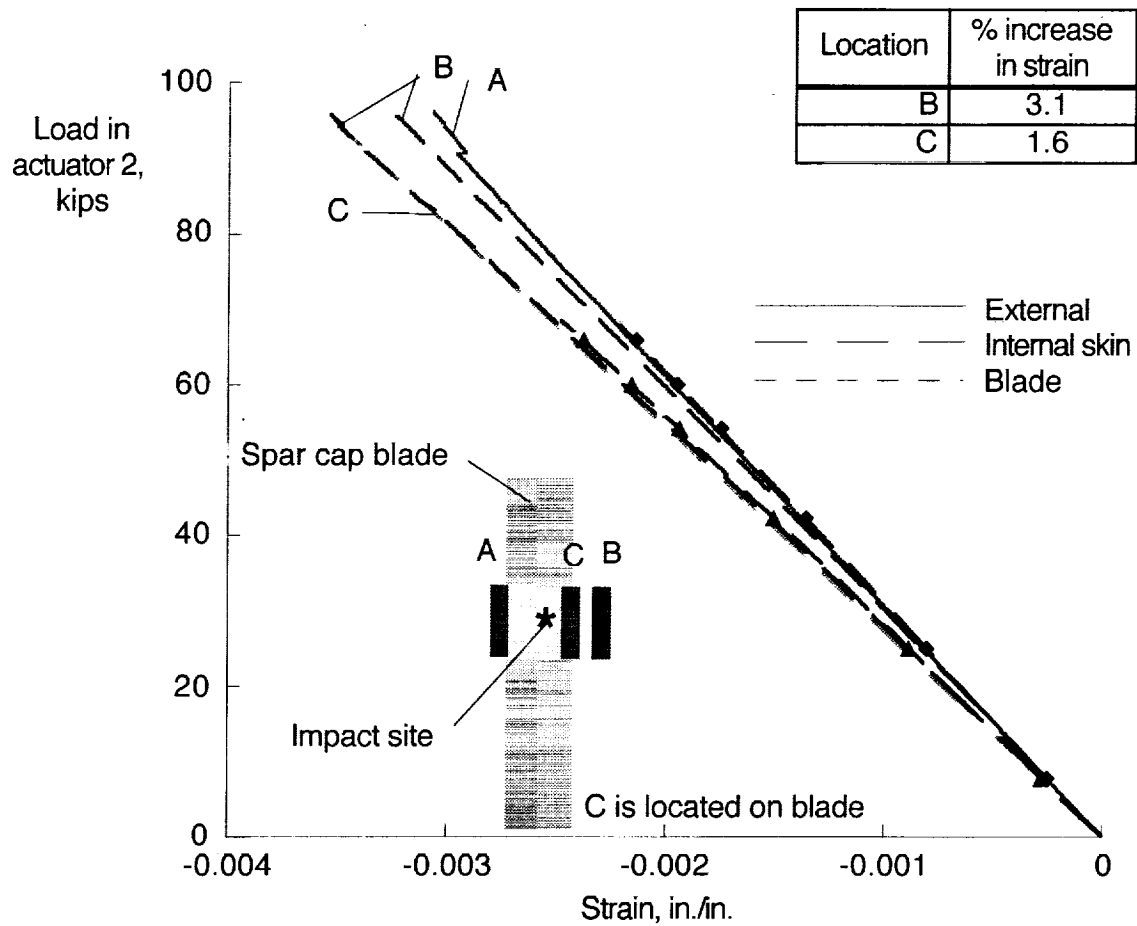
Strains in the upper cover panel at impacts at rib 4, at rib 9 and at rib 13 are shown in figures 68, 69 and 70, respectively. Internal skin strains are represented by long dashed lines and external skin strains are represented by solid lines. Blade strains are represented by short dashed lines. The lines with filled symbols represent strain of the undamaged structures. The lines with no symbols represent strain in the damaged structure. Strains at the rib 13 impact and the rib 4 impact remain linear as load is increased. At the load values corresponding to DLL, the strain increases at these two locations by no more than 4% due to the presence of the impact and strain does not exceed 0.005 in./in. in magnitude. The percentage increase in strain at each location is show on the figures.

Figure 68. Effect of impact damage on strain at upper cover rear spar cap near rib 4. Gage and impact locations are shown in figure 13c.

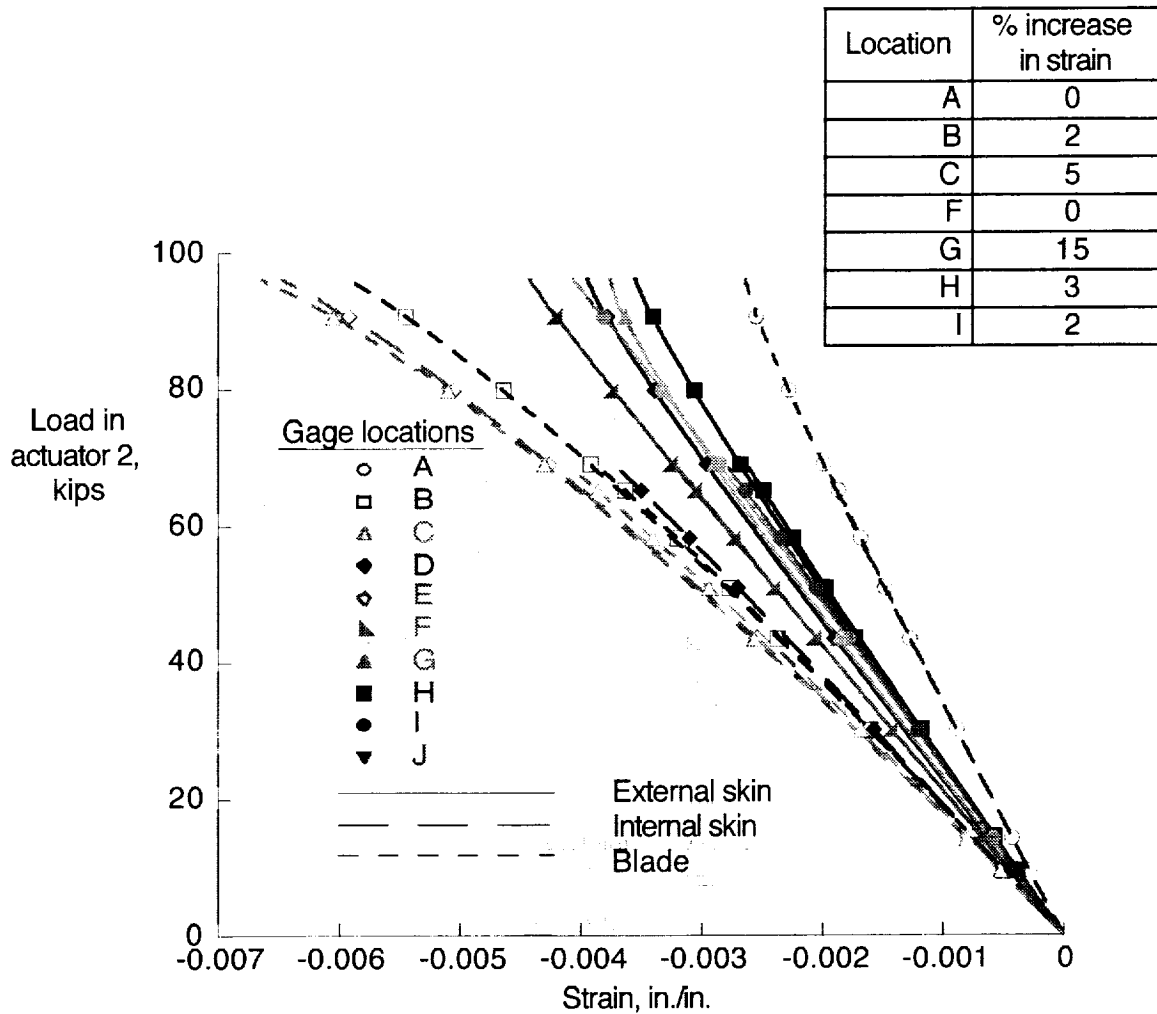
Figure 69. Effect of impact damage on strains at upper cover stringer runout at rib 9. Strain gage locations are shown on figure 3.

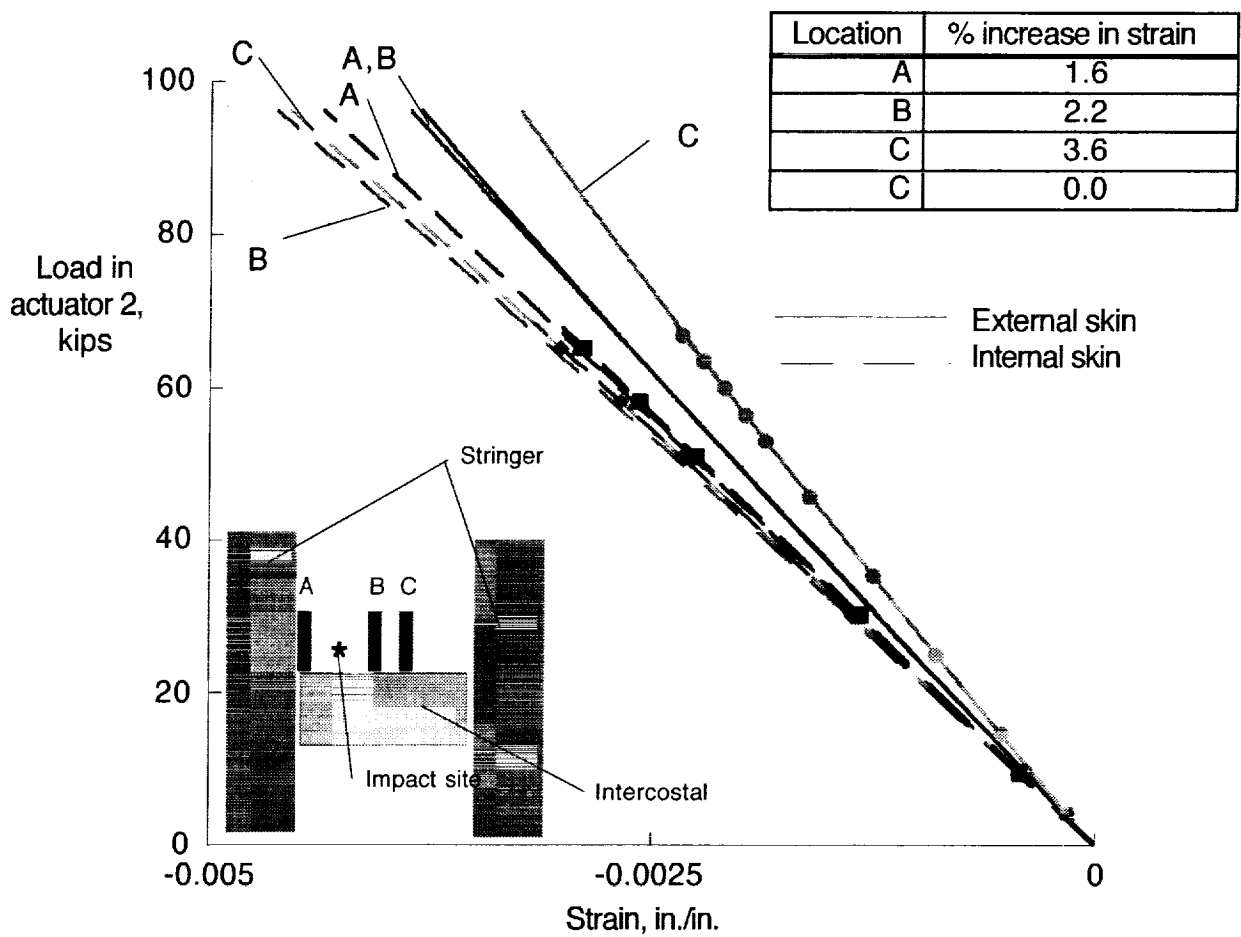
Figure 70. Effect of impact damage on strains in upper cover panel skin adjacent to rib 13. Strain gage locations and impact site are shown in figure 13a.

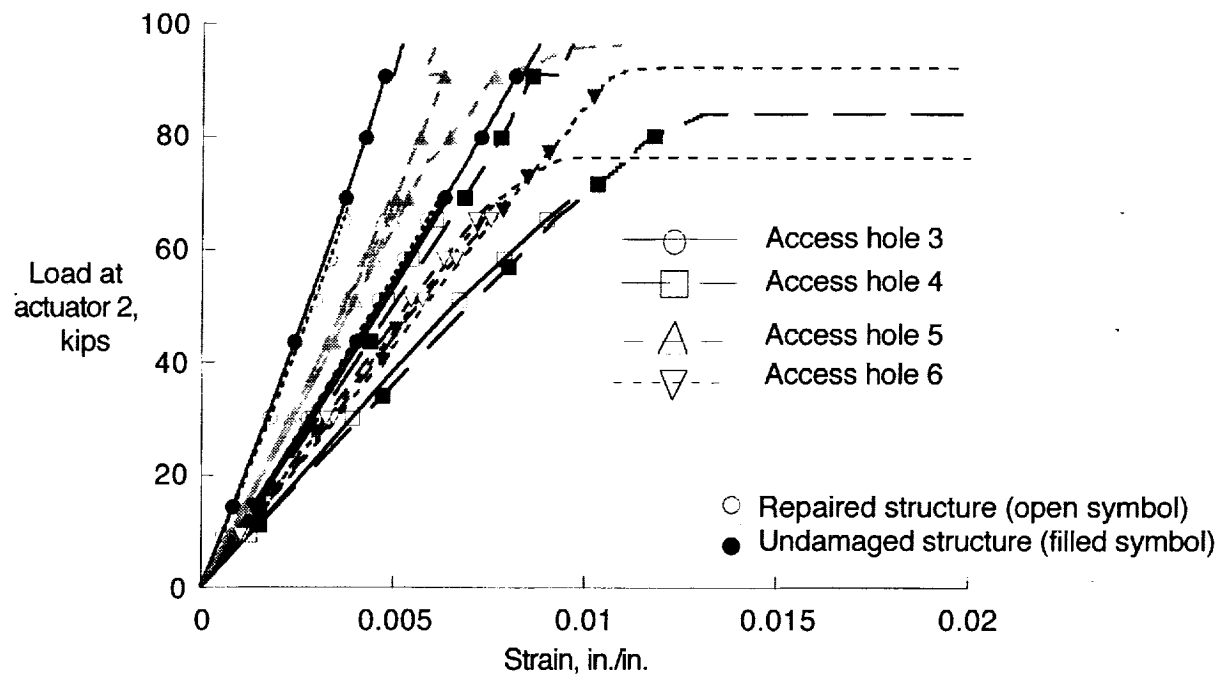
Figure 78. Measured strain at access hole edges for load to DLL and to failure in 2.5G load condition.

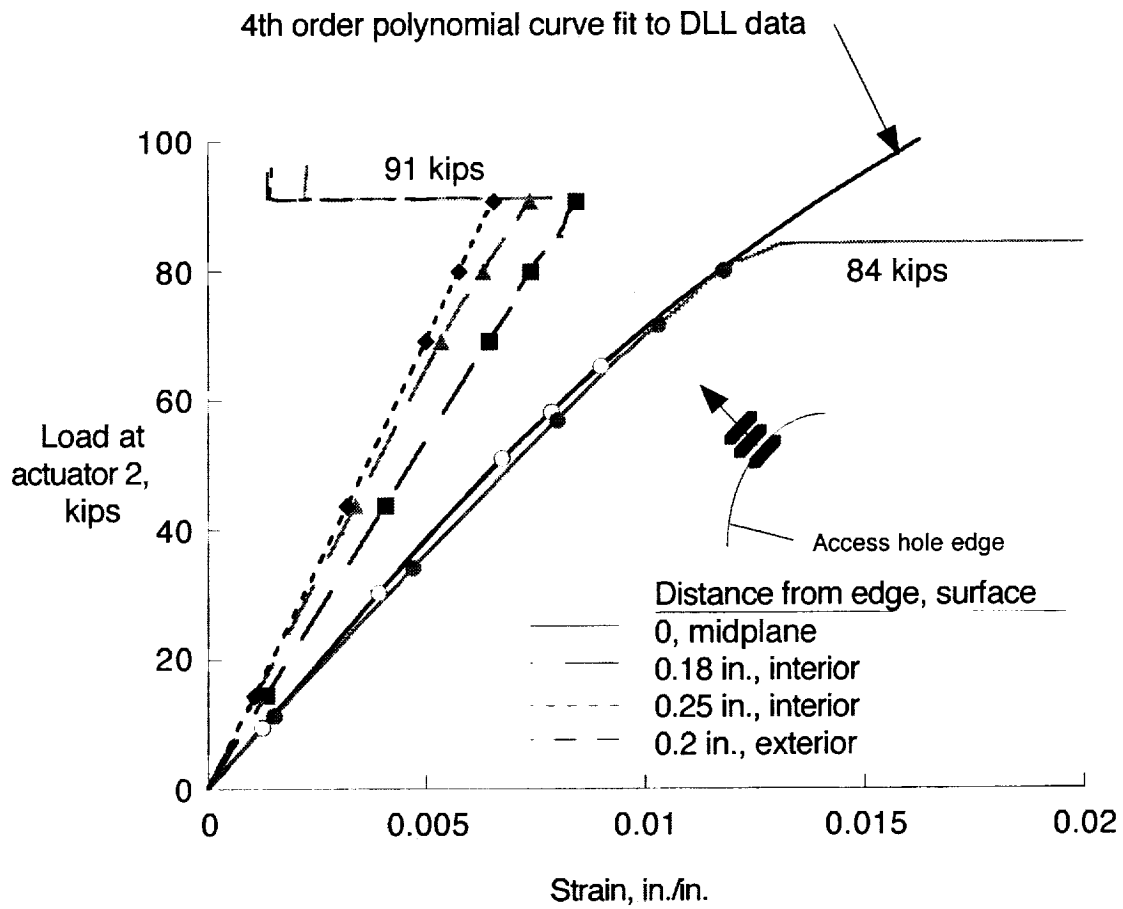
Access hole	Location	Load kips	Strain in./in.
4	outboard	84	0.0132
5	outboard	96	0.0104
6	outboard	76	0.0096
6	inboard	92	0.0112

Figure 79. Strain at edge of access hole four.
